Manhole Inspection Summary

Manhole # S25CC_057MH

Location Address: **821 FREMONT-ARLINGTON**

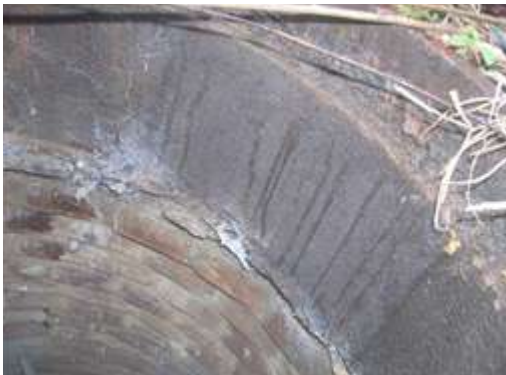
Defect 1

Condition: ☐ Sound ☐ Cracked ☐ Root Intrusion ☐ Loose Brick ☒ **Deteriorated**

chimney deterioration

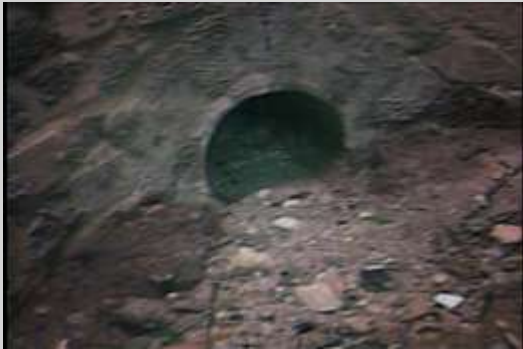
12 O'Clock Outflow

8 in. Circular Gravity Sewer
Pipe Out @ 12 O'Clock

Deposits: ☐ None ☒ **Mud** ☐ Sludge ☒ **Debris** ☐ Grease

Silt Depth: **2** (in.) Deposits Extent: **Light**
